**Missouri Department of Natural Resources
Water Pollution Control Program**

Total Maximum Daily Load (TMDL)

Kelley Branch

Rocky Fork

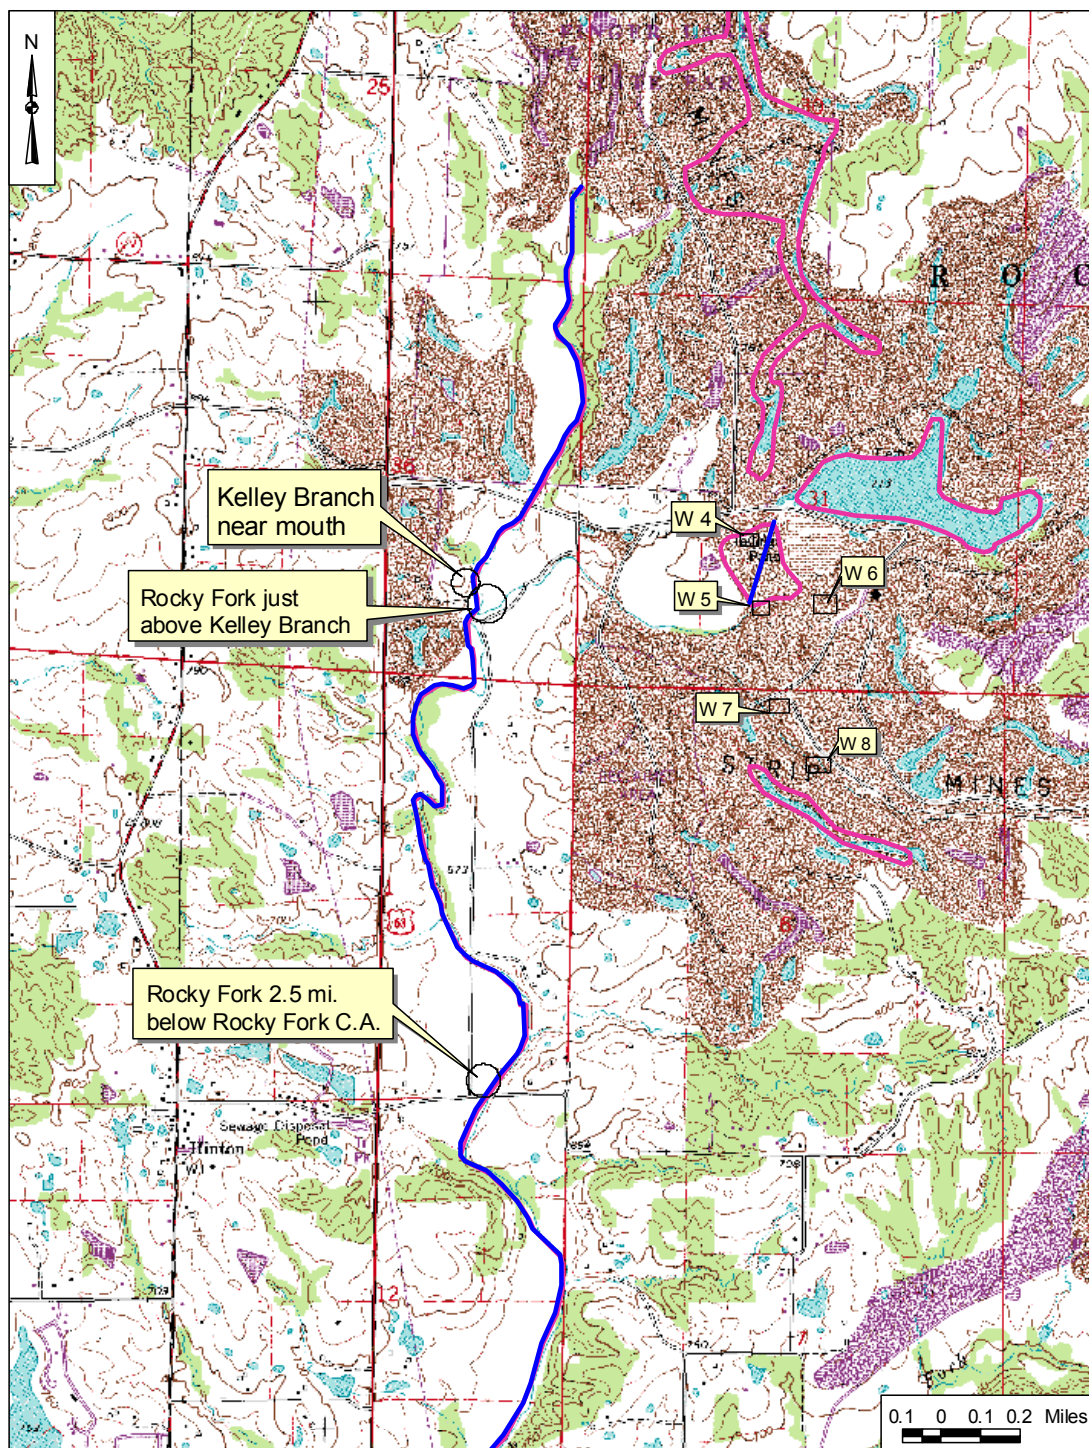
The following map shows sampling locations. W-4 through W-8 refer to locations in the chart above.

This area had received about 8 inches of rainfall in the last month but less than one inch in the preceding week. Despite the presence of small discharges of acid water from the spoil and gob area immediately south of the slurry pond, there was no evidence of acidity in Rocky Fork itself. There is a large wetland (60-70 acres) to the west that receives the drainage from about 98% of the slurry pond and the gob and spoil areas immediately south of the slurry pond. This wetland prevents loss of settleable and most suspended solids to Rocky Fork and provides buffering for acid drainage. At the current time, Rocky Fork does not appear to be affected by drainage from this site, but erosion gullies on the face of the slurry pond dam and the headcutting near the gob pile should be addressed to prevent the exposure of more acid forming materials.
